Mir Photo/TV Survey (DTO-1118): STS-84 Mission Report

Prepared by:
**Image Science and Analysis Group
Earth Science Branch
Earth Science and Solar System Exploration Division**

September 1997

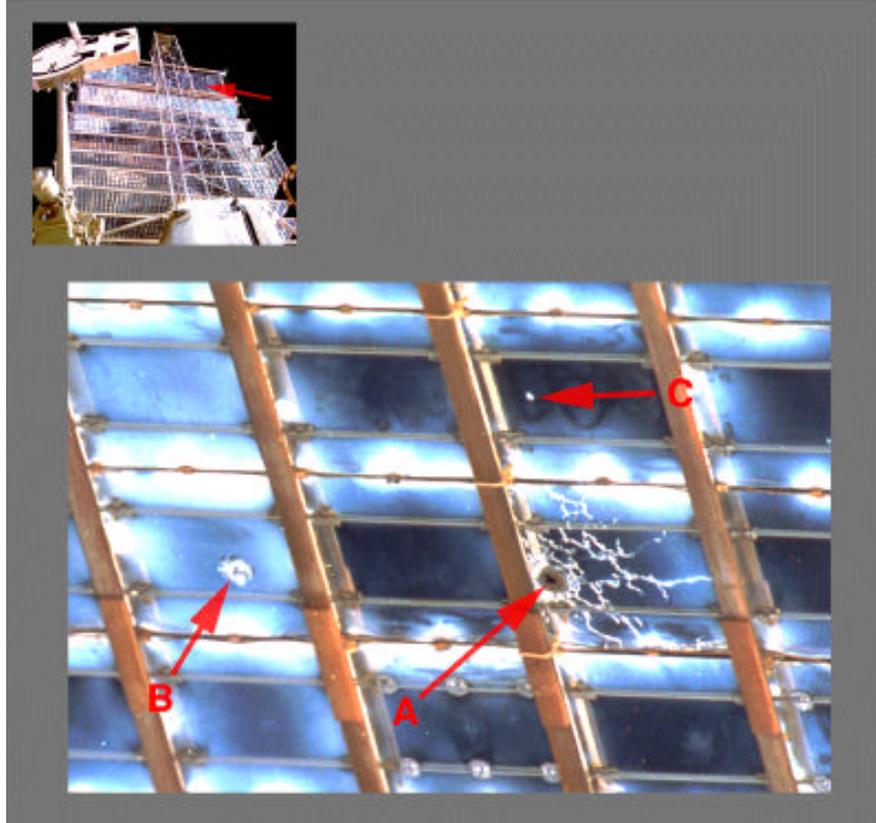
Figure 3.2 Kristall SP#2 MMOD Strikes

Figure 3.2 shows three distinctively different MMOD strikes on Kristall SP#2. The strikes A, B, and C are located on the outer petal of the solar panel as shown by the arrow in the figure inset. The strikes have not been detected in previous mission imagery.

Strike A has a black center with two concentric outer rings and a fracture pattern extending over the dimensions of the solar cell. The black center indicates an apparent pit or hole of average diameter 3.0 mm. The first ring from the center has a dark brown appearance and an average outer diameter of 8.2 mm. This dark brown area may be a spall area of the back side of the silicon cell. A second, bright reflecting, ring of shattered glass extends to an average outer diameter of 13.4 mm. The extended fracture pattern of cracks in the outer glass extends out to the edges of the solar cell which are 2 to 4 cm from the edge of the “bright ring”. The measurements are based on scaling of the individual solar cells of dimensions 5.0 cm on a side.

The strike labeled B has an apparent penetration hole or crater of average diameter 1.8 mm and a surrounding bright area of average outer diameter of 9.2 mm. The bright area may be a spall area of fractured glass.

The strike labeled C has a strike average diameter of 2.4 mm. There is no apparent central pit or hole, indicating the strike may be limited to the cover glass.

A region of 7 by 7 cells (35 cm x 35 cm) surrounding the three strikes above was examined for additional MMOD strikes. Five additional strikes ranging in size from 1.4 mm to 3.5 mm were found.

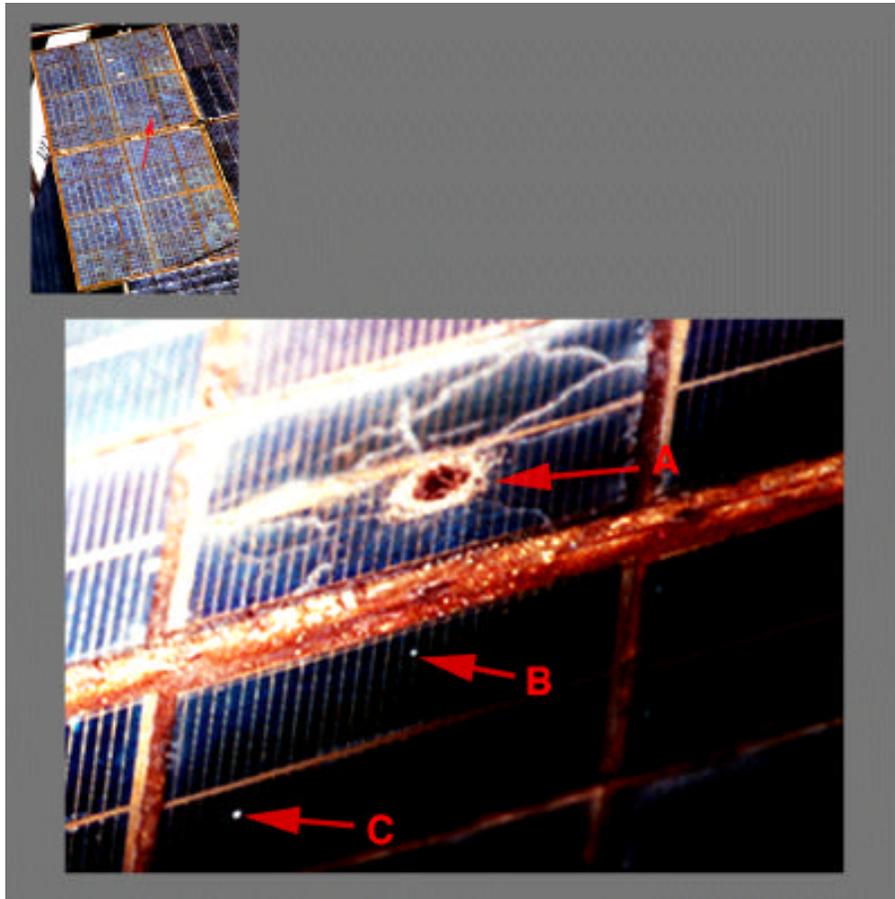
Figure 3.3 Base Block SP#2 MMOD Strikes

Strike A has a black center with two outer rings and a fracture pattern extending over the dimensions of a solar cell. The average diameter of the center black area is approximately 3.7 mm. The average outer diameter of the brown spall area is 6.6 mm and the average outer diameter of the bright area of shattered glass is 10.6 mm. The cracks extend to the boundary of the solar cell, which has been scaled from Mir drawing package measurements and images of the Base Block SP#2 to be 4 x 5 cm in size. The thin white lines within the cells are grid lines which collect electrical current generated by the cell. The wider horizontal white lines within the cells are ohmic bars which collect the current from the grid.

The small strikes B and C are measured to be 0.9 and 1.0 mm in size respectively. The uncertainty in the sizes of the strikes is approximately 10-15 percent (plus or minus) of the measured size of the strikes.

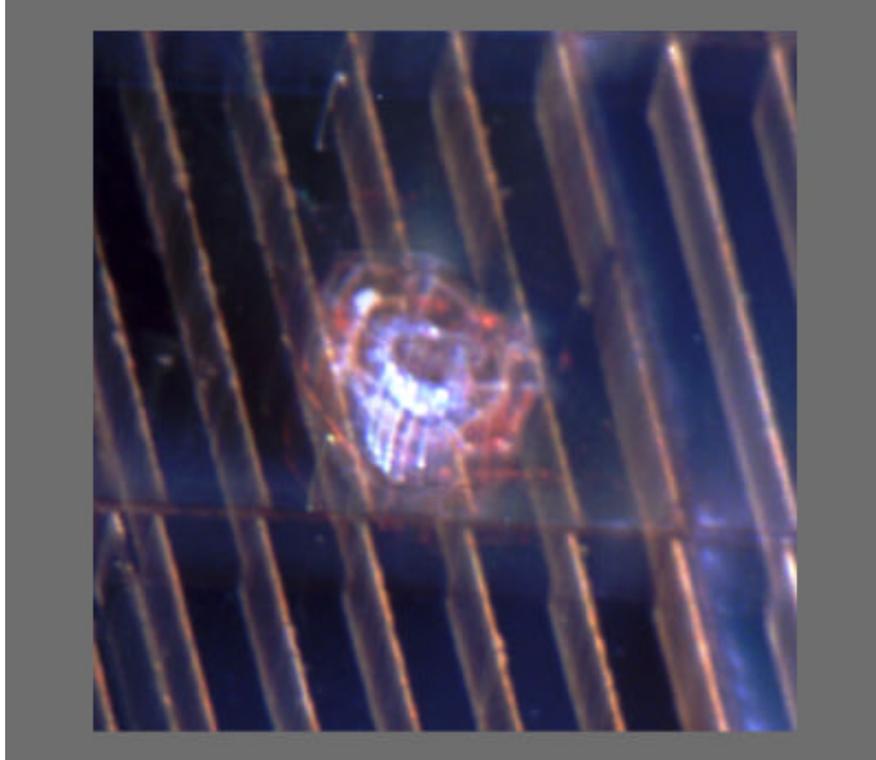
Figure 3.4 Circular MMOD Strike Pattern on Base Block SP#2

Figure 3.4 shows a circular MMOD strike on Base Block SP#2. The exact location of this strike on the Base Block #2 array has not been determined. However, the pattern of cells can be matched with areas of the Base Block SP#2 which appear to have cells of size 2 cm x 2 cm. According to information [Reference 7] by Dr. V. Khourunov of RSC-Energia provided to Thomas Kerslake, Lewis Research Center, Base Block SP#2 has both gallium arsenide and silicone cells of size 2 cm x 2 cm. It is not known which type of cell this is. The cell size boundaries were determined by multi-stage scaling from Mir drawing packages and imagery of varying scales collected on Shuttle/Mir flights starting with STS-63. On this basis, the dark central core of this strike is approximately 2 mm in diameter. Three rings extend outward from the central core. The first ring is a white area with an outer diameter of approximately 4 mm. This is apparently a spall area of shattered glass. The second ring is approximately 5 mm in diameter. This may also be a part of the spall area. The outer ring is approximately 8 mm in diameter. A count of 16 cells surrounding the strike in Figure 3.3 yielded five additional MMOD strikes in the size range 0.5 to 1.0 mm. Because the cell boundaries are difficult to identify for this image, the uncertainty of the measurements is greater here than in the previous strikes in

this report. The uncertainty is approximated to be on the order of 15-20 percent (plus or minus) of the measured strike size.

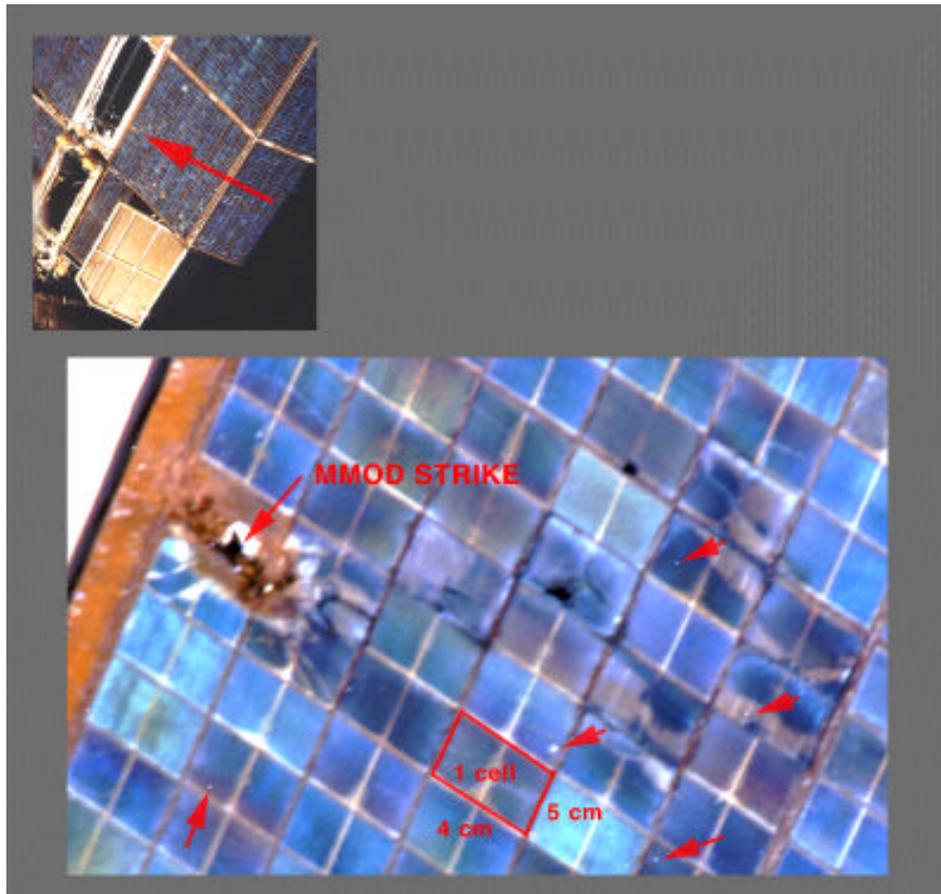
Figure 3.5 MMOD Strikes on Kvant-2 SP#2

Figure 3.5 is a detailed view of a MMOD strike on the Kvant-2 SP#2. This strike was described in the STS-81 Mission Report [Reference 6], however the STS-84 image is of higher resolution and provides improved definitions of the central pit, spall zone, and cell dimensions. This strike is somewhat different from the strikes shown previously in that a radial pattern of rings does not exist. The damage area is also larger than those shown earlier. Each individual cell is 4 cm x 5 cm in size, and the damage extends over 4 of the cells. The structural component on the left of the image is along the center of the solar panel as shown in the inset to Figure 3.5. Note that the oblique view of the image distorts the aspect ratio of the sides of the cell. Compare to the back-side view (Figure 3.6) which is a nearly perpendicular view. The ohmic bars show in the front-side view but not in the back-side view.

structural member. The total size of this brownish area is 7.3 cm x 7.5 cm in the longitudinal and transverse directions respectively. In addition, the splatter of the brownish substance appears to extend onto the edges of adjacent solar cells. The cover glass is possibly removed from one of the cells and portions of the other three cells. The cracks in the cover glass extend over the three cells.

It is not known whether the anomalous appearance of nearby cells is associated with the MMOD strike. A count of probable strikes over an area of 190 cells adjacent to the strike above yielded 19 strikes in the size range of 2.5 to 5.5 mm. The arrows in the figure point to some of the nearby MMOD strikes. The nearby strikes are not thought to be secondary strikes from the large debris strike because they are widely dispersed (in an area greater than 120° around the impact site). The uncertainty in the sizes of the strikes is estimated to be 10-15 percent of the size of the strike.

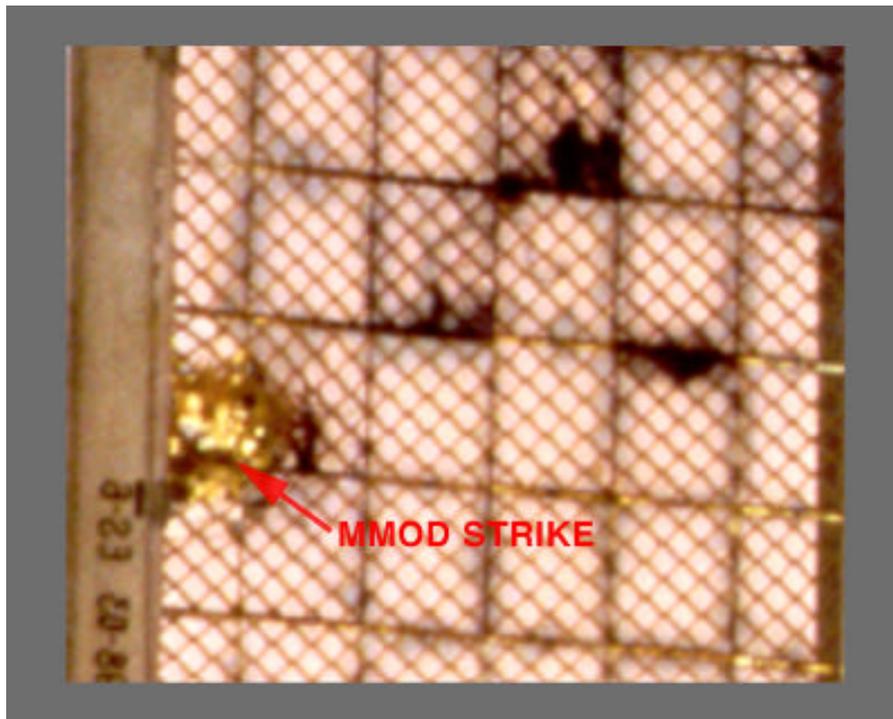
Figure 3.6 A View of the Back Side of Kvant-2 SP#2 MMOD Strike

Figure 3.6 shows the area of the debris strike on the backside of Kvant-2 SP#2 taken on STS-71. It is possible that the strike may have first impacted the backside of the solar arrays causing the damage observed on the front side shown in Figure 3.5. However, this has not been confirmed. The black central pit or hole has a similar shape on the back side as exists on the front side. The light colors are consistent in color with the back side of the solar cells and the supporting mesh. The light brown/yellow zone surrounding the dark central region corresponds to the regions where the cell cover glass has been removed on the front. The three nearby black areas correspond to cells which may be partially delaminated, but are not indicated as MMOD strikes. The larger rectangular grid in the image are the cell boundaries.

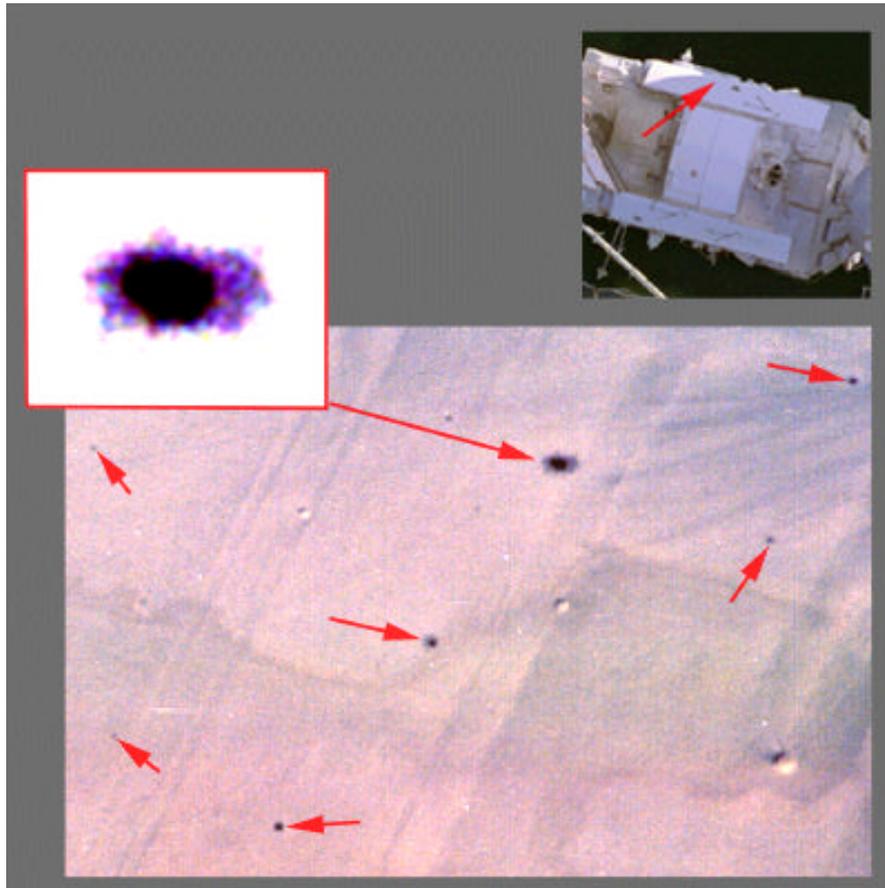
Figure 3.7 Possible MMOD Strikes on a Portion of Kvant-2 Radiator

Figure 3.7 is an extraction from a photograph which shows possible MMOD strikes on the radiator located on the -X, -Z side of Kvant-2 as shown in the inset image of Kvant-2. The larger strikes have an appearance similar to those shown on the solar arrays. They have a dark (black) central pit or hole surrounded with an apparent spalled zone where the white paint has been possibly removed. The larger strike has a central pit of approximately 10.9 mm in diameter and a spall zone of approximately 19.7 mm in diameter. Six additional possible debris strikes (denoted by arrows) are shown, with central pit diameters ranging from 3.3 to 5.5 mm in diameter. The other circular features on the radiator are rivets or round-head bolts, and can be identified by their highlights and shadows. The portion of the radiator shown in this figure is approximately 1630 sq cm in area. The possible strikes shown here are more uniform in diameter than the ones shown

previously. The uncertainty in their size is approximately 10 percent (plus or minus) of their measured size.

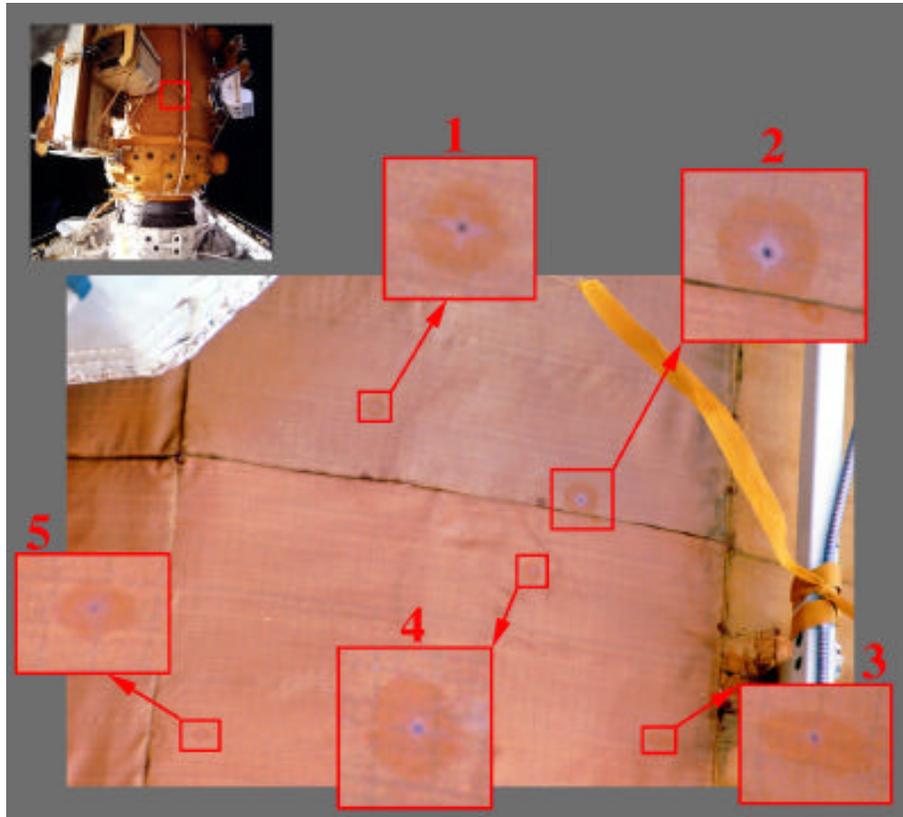
Figure 3.8 Possible MMOD strikes on Docking Module Thermal Blanket

Figure 3.8 shows six possible MMOD strikes in the Docking Module thermal blanket on the +XB side between the RSA and the OPM [1-5]. Inset 2 includes two strikes; the largest and the smallest strikes in the photograph. Each of these strike areas has a dark center surrounded by a white circular region. Outside this region is a much larger, dark circular region. Similar ringed features of MMOD strikes were observed on silver teflon thermal blankets and certain painted surfaces on the Long Duration Exposure Facility (LDEF) [Reference 8].

The largest strike has a dark center of 2.6 mm diameter, a white ring of 8.3 mm diameter, and a dark outer ring of 26.5 mm diameter. The smallest strike has a dark inner circle of 0.5 mm diameter, a white ring of 1.8 mm diameter, and a dark outer ring of 5.7 mm diameter. The surface area covered by the photograph is approximately 580 x 380 cm.

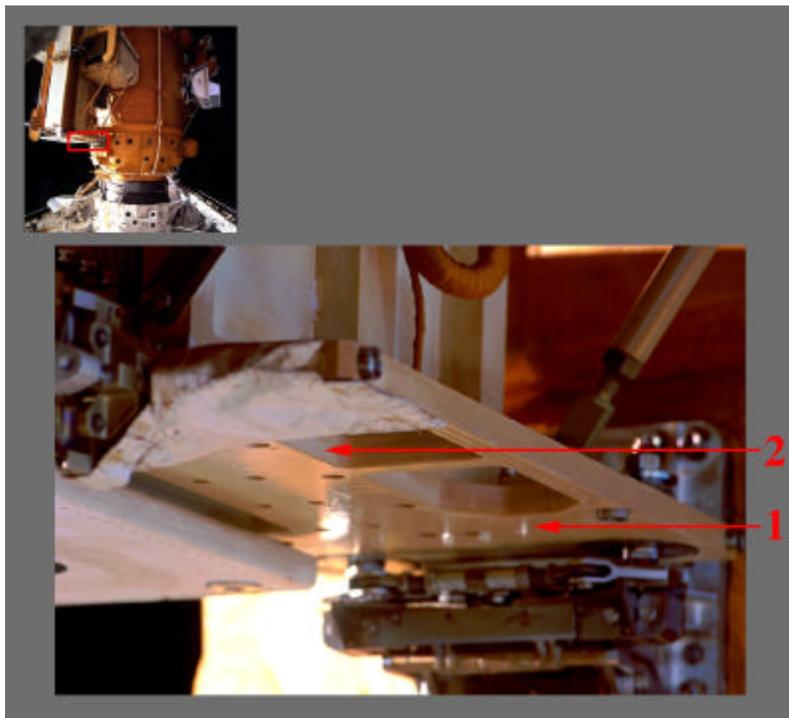
Figure 3.9 Deposition on Base of RSA Carrier

Figure 3.9 is the highest resolution photograph to date of the base of the RSA which faces the Shuttle during the docked phase. Photography from previous missions showed deposition on this surface. However, higher resolution and improved lighting reveal the consistency in deposition across the outer plate of the corner [1], which was originally white. Inner edges [2] of holes cut out of the plate do not appear to have received as much deposition as the outer surfaces.

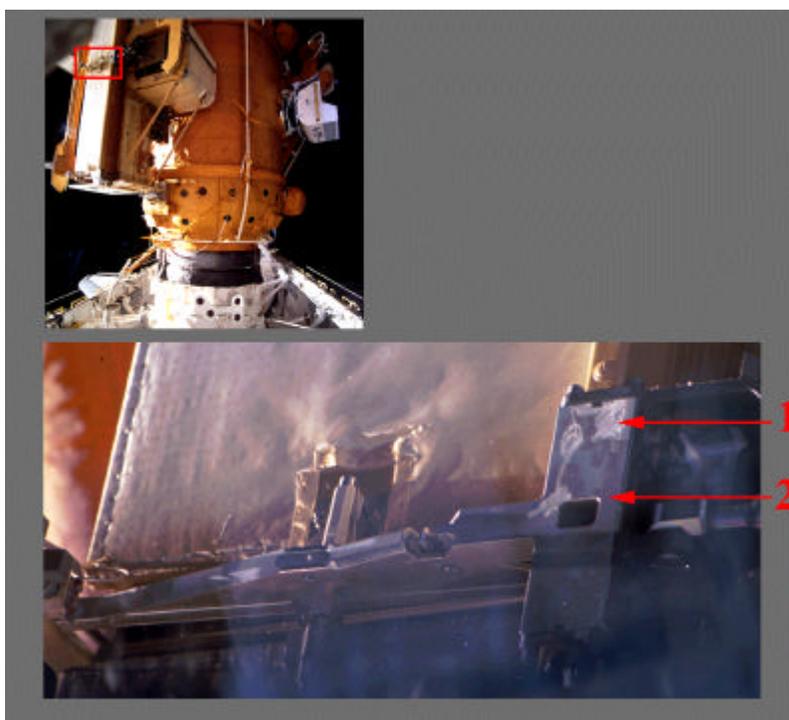
Figure 3.10 Irregularity on Surface of an RSA Carrier Hinge

Figure 3.10 is a photograph of the surface of an RSA Carrier Hinge which appears to have some surface anomaly, possibly a scratch [1]. This area is white in color, and this may be due to the surface being more reflective than the surrounding area which is gray in color. This scratch has not been seen previously. In addition, there are some brown areas of discoloration which were also visible in photography from STS-76 [2].

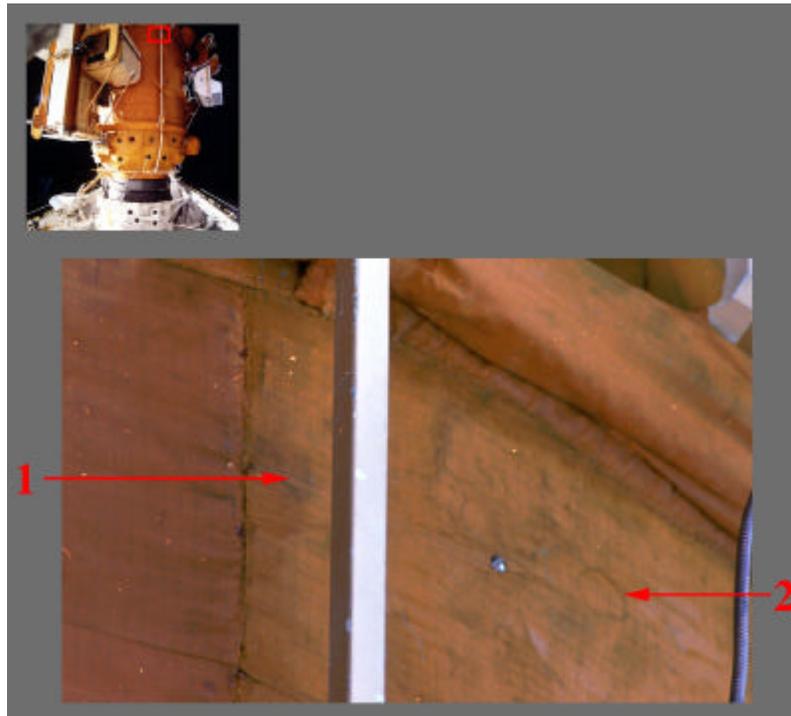
Figure 3.11 Discoloration and Possible Stain on Docking Module Thermal Blanket

Figure 3.11 is a photograph of the thermal blanket on the Docking Module. There is a region of the blanket which has an uneven dark discoloration [1]. There is a circular stain which suggests that a contaminant may have permeated the surface or leached through from underneath the surface [2]. The photographs taken during this mission are the highest resolution to date of the thermal blanket.

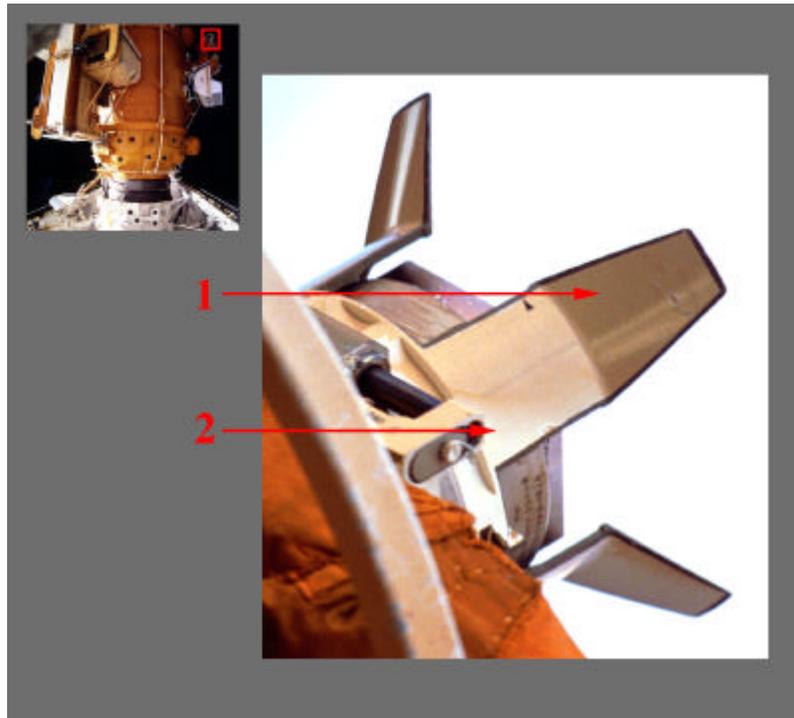
Figure 3.12 Docking Module - ROEU-PDA

Figure 3.12 is a photograph of a large area of dark deposition on at least one of the four prongs on the Remotely Operated Electrical Umbilical (ROEU) Payload Disconnect Assembly (PDA) [1]. A small region of this same prong [2] appears to have received little deposition since it remains white in color. This preferential pattern of discoloration may suggest that the trajectory of the contaminant causing this deposition remains relatively constant. The JSC Cargo Engineering Office is concerned that deposition on the surface of the connectors could cause uneven thermal cycling, thereby reducing the lifetime of the connector.

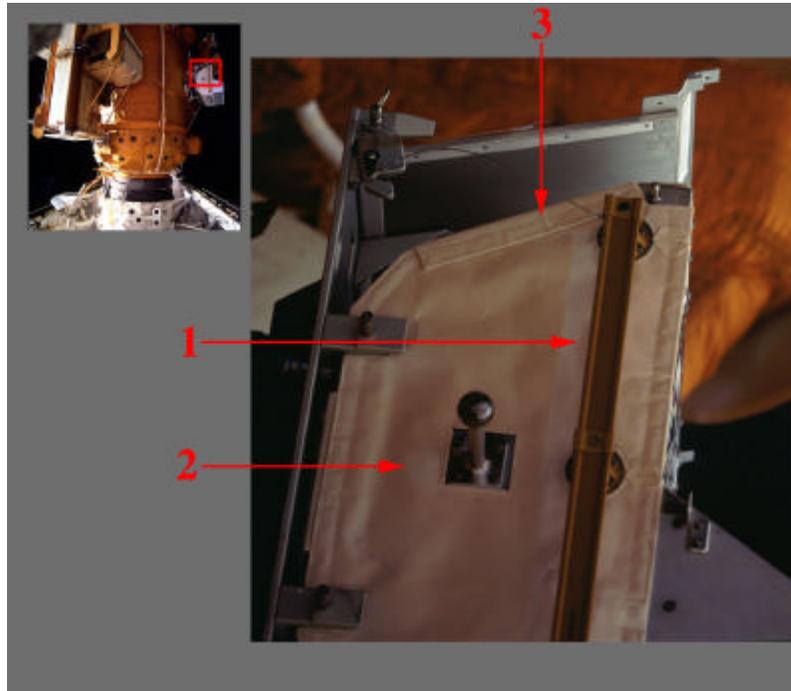
Figure 3.13 Docking Module - OPM

Figure 3.13 is a photograph of the OPM which was deployed on the Docking Module during an EVA on April 29, 1997. This photograph, taken around May 20, 1997, reveals deposition on a thermal blanket covering the end of the OPM facing the (+XB) direction. There is a highly preferential pattern of discoloration on this thermal blanket. There are areas to the left of the handrail and Mir crane interface in this picture that appear to be receiving little deposition [1, 2 respectively]. These objects protruding from the surface appear to block the deposition which is striking the rest of the thermal blanket, creating a “shadow” of these items to the left of the actual object. The direction the contamination is originating from appears constant enough for even the thinnest object, in this case a wire attached to the handrail, to cast a “shadow” [3].

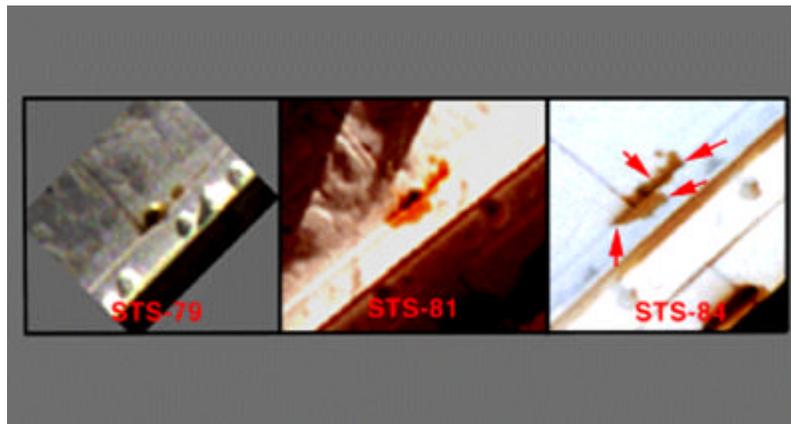
Figure 3.14 Progress of Possible Leak on Spektr Radiator

- A possible leak on the Spektr radiator, discovered during STS-81, was photographed on STS-84. The stain from the leak showed only a small increase in size between STS-81 and STS-84. The stain is shown in Section 3, Figure 3.14.

Figure 3.14 shows the progression of a possible leak on the Spektr radiator. This possible leak was first identified on the STS-81 Mir survey imagery. This leak appeared as an orange-colored stain on the radiator. A review of previous mission imagery showed the leak originated between the STS-74 and STS-76 missions. However a significant increase in size occurred between the STS-79 and STS-81 missions. The progression of the leak from STS-79 to STS-84 is shown in Figure 3.14. There were additional increases in the area of the leak as shown by the arrows in the STS-84 image. However, the increases were small and did not show the dramatic increase in area that was observed in the STS-81 imagery. The size of the leak remained at approximately 7 sq cm.

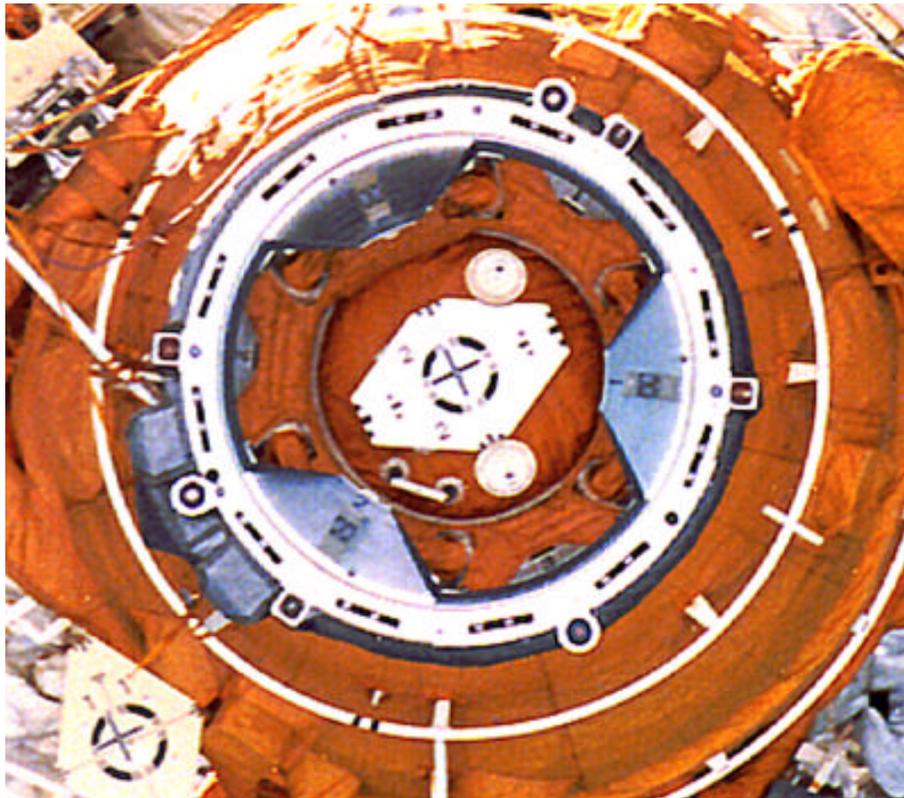
Figure 4.1 Photo of Docking Mechanism during Approach

Docking occurred during darkness for STS-84. The video imagery obtained with the ODS centerline camera during approach showed the docking target to be in good condition. However, there were significant reflections in the video when the docking latches were in the field-of-view and the video was focused on the docking target. The video imagery was not suitable for assessment of the docking latches, alignment guides, electrical connectors, or retroreflectors. However a view taken with the 35 mm camera and telephoto lens during approach was sufficient to show the capture and structural latches were in proper position and the centerline and non-axial targets in good condition. The retroreflectors and electrical connectors appear to be in good physical condition, however, the imagery was not of sufficient resolution to detect discolorations that might exist. The image is shown in Figure 4.1.

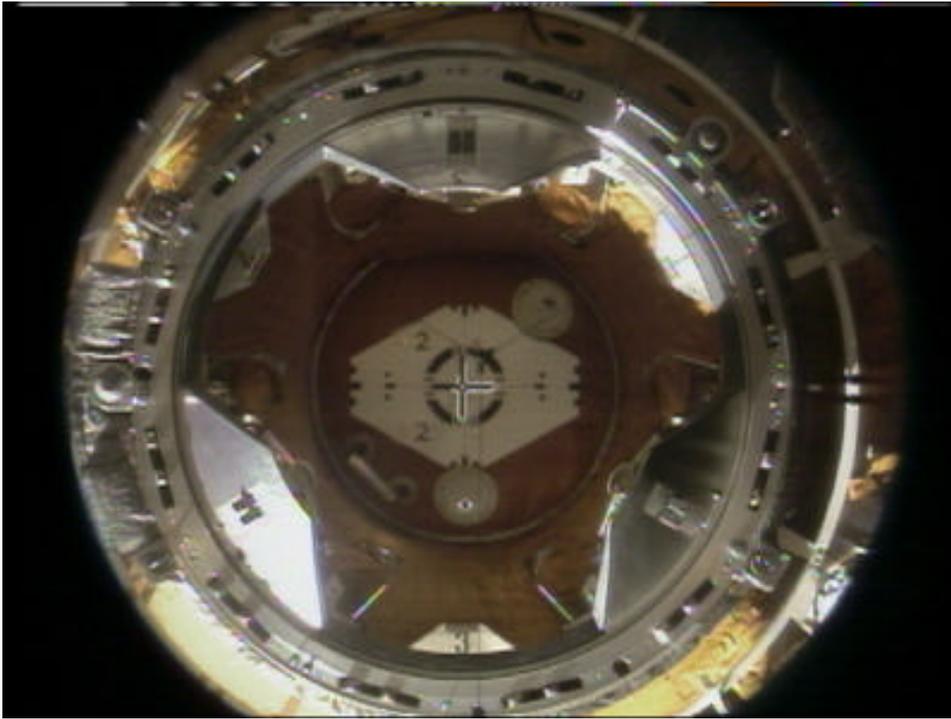
Figure 4.2 Video of Docking Mechanism during Backaway

Undocking and backaway also occurred during darkness. During backaway, however, the centerline video camera was set to a larger field-of-view than for docking, and video was obtained of the docking mechanism without the reflections observed during

approach. This video shows the capture and structural latches to be in the proper position and the docking target to be in good condition. The electrical connectors and retroreflectors appear to be in good physical condition, however the video is not sufficient to detect significant discolorations. The video image is shown in Figure 4.2.

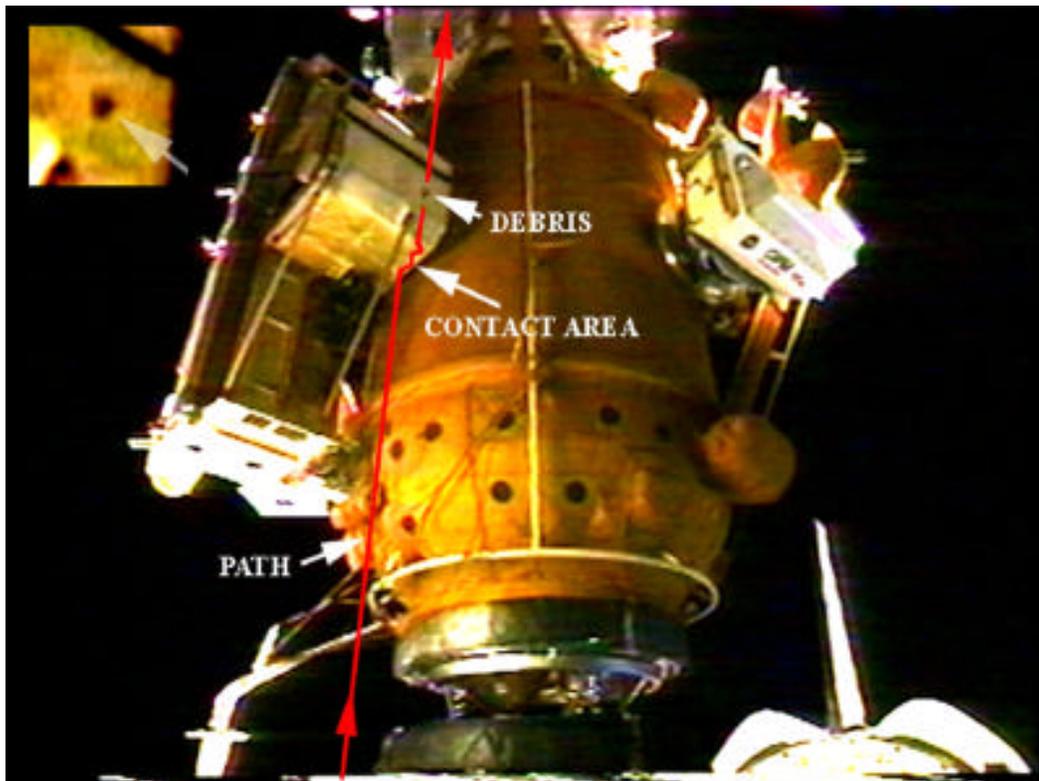
Figure 6.1 Debris Observed Making Contact with RSA Carrier at GMT 137d:02h:36m:28s

However, three minutes and thirty-one seconds after docking contact, a single piece of debris was observed moving vertically in the Shuttle +Z direction in the line-of-sight between PLB camera A and the Docking Module. This piece of debris and its path are shown in Figure 6.1. The debris is observed to make contact with the thermal blanket on the lower side of the Reusable Solar Array (RSA) carrier, deflect several times and continue on its +Z path. The exact shape of the debris cannot be determined, but appears to be a polyhedron as shown in the inset in Figure 6.1. Because the debris makes contact with the RSA carrier, it is possible to make an estimate of the velocity of the debris by scaling its distance with the adjacent DM dimensions. Prior to making contact the +Z velocity is approximately 25.4 cm/sec. Its +Z velocity after making contact and continuing on its new

path is approximately 10.4 cm/sec. The component of velocity in the direction parallel to the X-axis of the video image plane changed from approximately 3.6 cm/sec to approximately 1.2 cm/sec. The diameter of the debris is approximately 4.3 cm. An examination of the film photography of the RSA carrier, taken while the Shuttle was docked, did not indicate any damage to the carrier thermal blanket as a result of the debris contact.

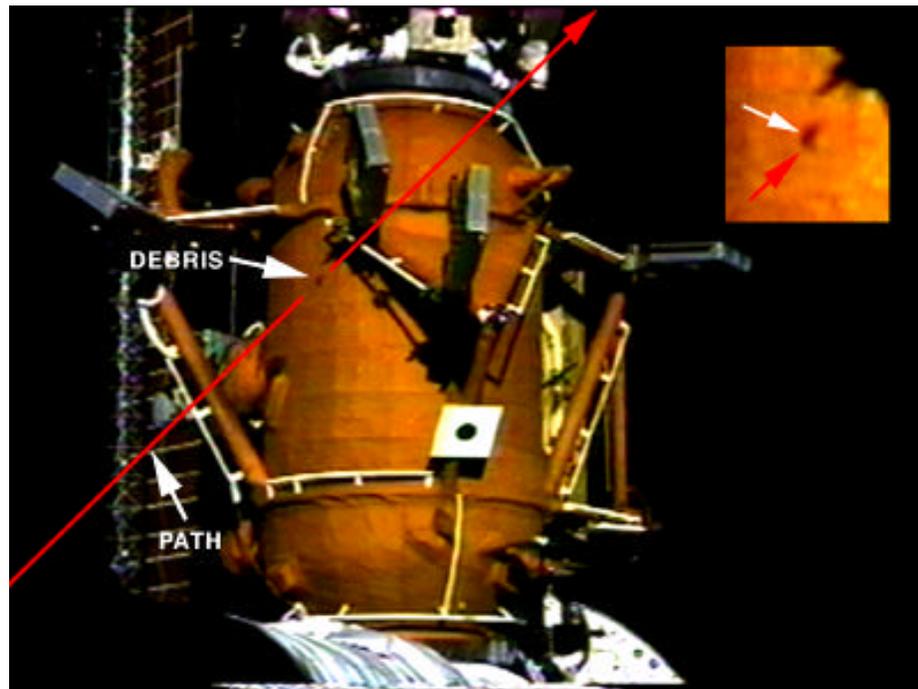
Figure 6.2 Spherical Debris Observed between PLB Camera C and Mir Docking Module at GMT 137d:02h:39m:54s

Three minutes and twenty-six seconds after the above debris was observed, a second piece of debris was observed as shown in Figure 6.2. This piece of debris was recorded by PLB camera C and traversed a path between PLB camera C and the Mir DM. This debris appears to be spherical in shape. The path of the debris indicates that the debris originated from the aft bulkhead area of the PLB. The distance of the debris from the camera cannot be determined and therefore the size and velocity of the debris cannot be determined.

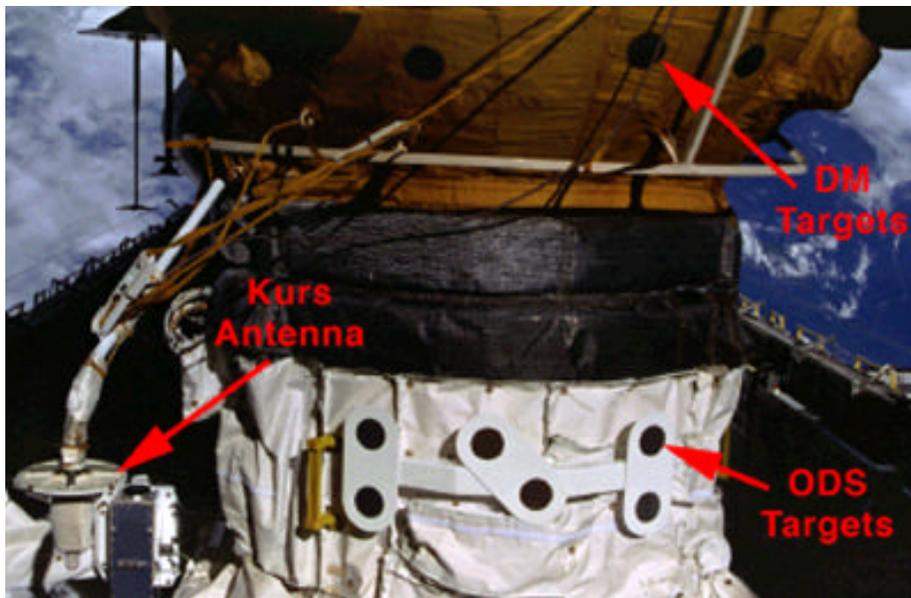
Figure 8.1 Kurs Antenna as seen from the Shuttle Flight Deck on STS-84

Between STS-79 and STS-81, a Kurs antenna was attached to the Mir Docking Module. This Kurs antenna extends toward the Shuttle forward bulkhead as shown in Figure 8.1. The JSC Structures and Mechanics Division requested that an analysis be performed to determine the position of the tip of the antenna from STS-81 and STS-84 imagery. This information will assist the group in determining the clearances between the antenna and the Shuttle Payload Bay forward bulkhead. The STS-81 results were included in the DTO-1118 STS-81 Mission Report (JSC-27932). The following describes the STS-84 analysis and results.

84 analyses are accompanied by an uncertainty estimate derived from a standard Monte Carlo error estimator. Both the STS-84 and STS-81 results indicate a clearance of 109 inches between the tip of the antenna and the Shuttle forward bulkhead.
